Architectural Retrofit of Building Structure: Architectural Strategies on the Construction Defect of Mid-Rise Building

Abstract. Due to unsafe and unstable conditions, construction defects in mid-rise buildings have led to unfeasible occupancy. Building demolition is not a viable solution when architectural retrofit strategies can prevent demolition and reconstruction. These strategies are part of sustainable development, aiming to prolong building lifecycles and lifespans. New advanced materials in construction have facilitated the retrofitting of defective building structures. Carbon Fiber Reinforced Polymer (CFRP) and Ultra High-Performance Concrete (UHPC) serve different primary purposes; however, they work together to strengthen building structures. CFRP is effective for tensile strength, while UHPC is advantageous for compressive strength. This paper explains how architectural retrofit strategies can address building defects resulting from workmanship deficiencies that do not meet structural standards, such as improper moulding, concrete mixtures, and steel joint reinforcement. The research employs experimental techniques on a mid-rise building with structural defects to ach

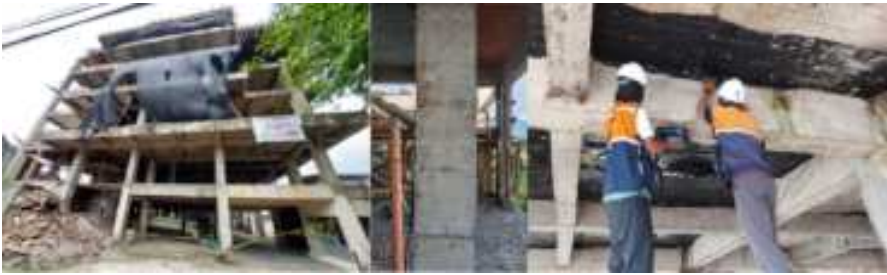
Fig. 1. Documentation of construction defects (left), horizontal assessment sample on slabs and documentation of structural assessment for beams and columns (middle and right).

Based on concrete and steel reinforcement quality assessments of columns and beams, the mid-rise building had safety and stability issues. Many structural defects were in columns, including concrete erosion and cold joints. Column and beam eccentricity were not aligned and not perpendicular. Besides, the column and beam needed to be appropriately attached. The column dimensions were wider, from the second to sixth floors, than specified in the drawing plans. The plans showed steel reinforcement using hot-rolled deformed bars; however, mild steel round bars were used instead [1]. The gap distance between stirrup reinforcements for the columns was twice as long as specified in the drawing plans [1].

Moreover, the structural assessments indicated safety and stability issues with the beams in the mid-rise building. The beams exhibited different dimensions and forms, particularly between the second and sixth floors, where the difference in beam thickness ranged from 60 to 150 mm [1]. Beam reinforcement utilized mild steel round bars that did not adhere to the drawing plans; the stirrup reinforcement gaps were longer than specified [1]. Additionally, the condition of the beams showed numerous fractures, exposing their reinforcements. For slab problems, the concrete moulding was contoured, with height variations between 100 and 200 mm [2]. Additionally, the quality of the

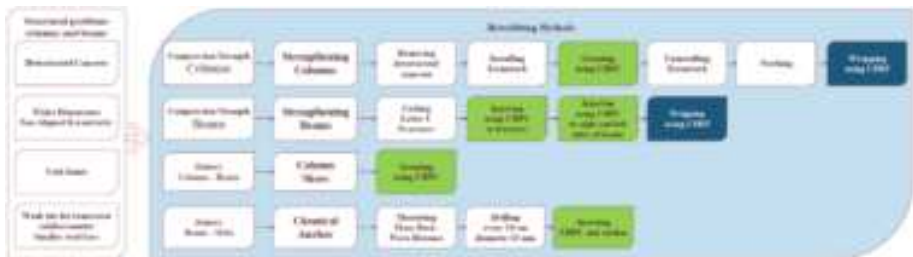
1. Strengthening columns use grouting, UHPC to fix concrete problems, wrapping, and CFRP to fix weak ties for transverse reinforcements and smaller steel bars.
2. Strengthening beams utilise injecting methods using UHPC and stripping using CFRP.
3. Column-beam joinery uses column shoe methods with UHPC.
4. Beam-slab joinery using chemical anchor with UHPC and steel anchor.

Fig. 3. Retrofitting Methods for structural defects of a mid-rise building

At the end of this experimental method, researchers evaluate the methods by measuring compressive strengths using samples for concrete crushing tests. After the UHPC and CRFP applications, the evaluation aims to measure the compression strength alterations (Fig. 3).

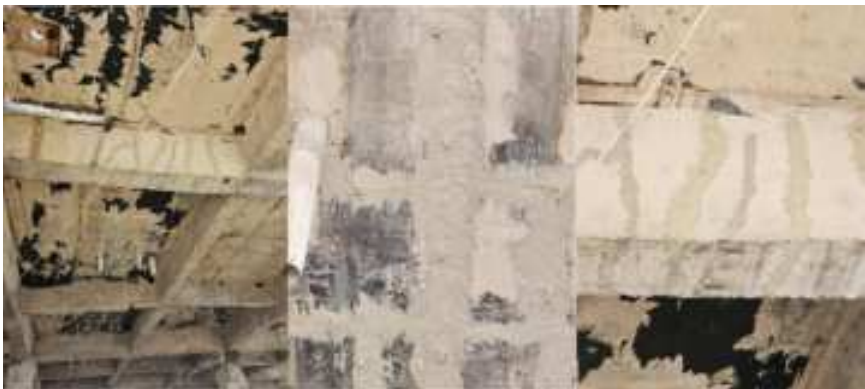
Fig. 4. Retrofit Applications using UHPC for columns and beams.

Retrofitting columns and beams face similar problems for deteriorated concrete, weak ties of transverse reinforcements, unaligned eccentricity, and thicker concrete cover. Deteriorated concrete on columns and beams has lessened compression strength, rigidity, and durability. Preserving hard concrete and dismantling porous or deteriorated concrete were beneficial to minimise construction waste [13] and reduce energy needs [14]. The first step is removing deteriorated concrete in columns and cutting letter U fractures in beams. The practical technique is grouting Ultra-High Performance Concrete (UHPC) on the remaining parts of hard concrete in columns, injecting UHPC in beams, and utilising UHPC rather than standard concrete due to the project's need to recover structural defects. UHPC are composite materials to strengthen concrete fractures and structures by adding compressive strength [8, 9]. Meanwhile, standard concrete used for existing structures faced durability and compression problems (Fig. 4).

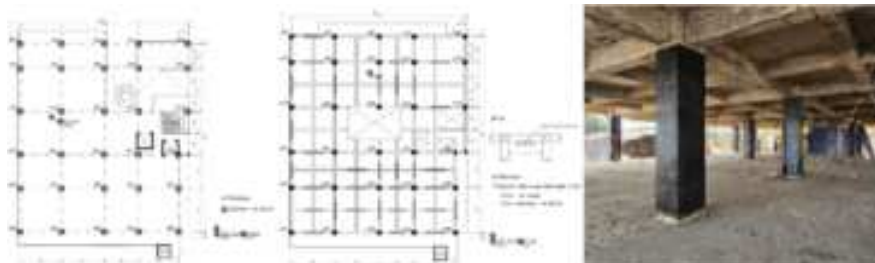
Fig. 5. Retrofit Applications using CRFP for columns and beams

The wrapping technique utilises Carbon Fiber Reinforced Polymers (CFRP) made of lightweight materials. CFRP enhances tensile strength for building structures by preventing cracking and shear failure, as well as increases compressive strength by adding load-carrying capacity and stiffness [6]–[8]. In this case, CRFP wrapping is the most effective technique after UHPC grouting and injection to amplify ties of transverse reinforcement rather than the jacketing technique. CRFP techniques for this case are wrapping around columns and stripping along beams. Before doing this, the architect team prepared drawings for wrapping column locations and stripping beam locations (see Fig. 5).

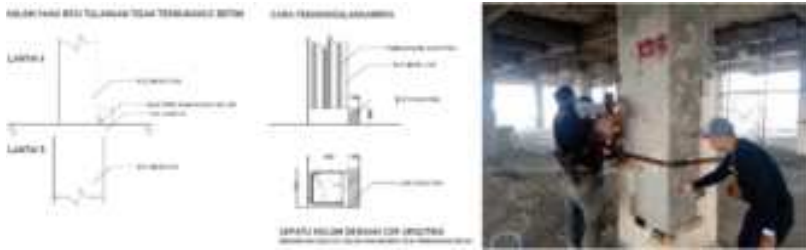
Fig. 6. Retrofit Strategies of Construction Defect of Mid-Rise Building using UHPC for columns shoes and CFRP for wrapping columns.

Retrofitting joinery strategies aim to improve cold joints in columns-beams and non-proper detachment beams-slabs. Incorrect casting method caused cold joints that reduced durability, were prone to shear or tensile forces, and lessened load capacity – compression strength. Accordingly, column shoes manage column-beams joinery on every storey of the building. Column shoe technique uses Ultra-High Performance Concrete (UHPC) on each based column for binding purposes. On the side, a method enhances beam stiffness from lateral forces by binding slabs with beams. The existing condition showed no ties between slabs and beams. The most effective technique to enhance beam-slab stiffness is the chemical anchor. Chemical anchors use UHPC to tie up, and steel is for anchors. Thus, beams-slabs use drilling techniques to inject UHPC and insert anchors (Figs. 6 and 7).
